# SUCCESS STORY

## Alliance AF 333 performs flawlessly for this French logger!

**Customer** : Mr. Hubert Terrillon  
**Location** : 21400 Ampilly le Sec, France  
**Machine used** : Valtra 6350 & Igland Trailer  
**Application** : Forestry  
**Tyres in use** : AF333 380/85-28 139A8  
AF 333 460/85-38 154A8  
F328 400/60-15.5 14PR

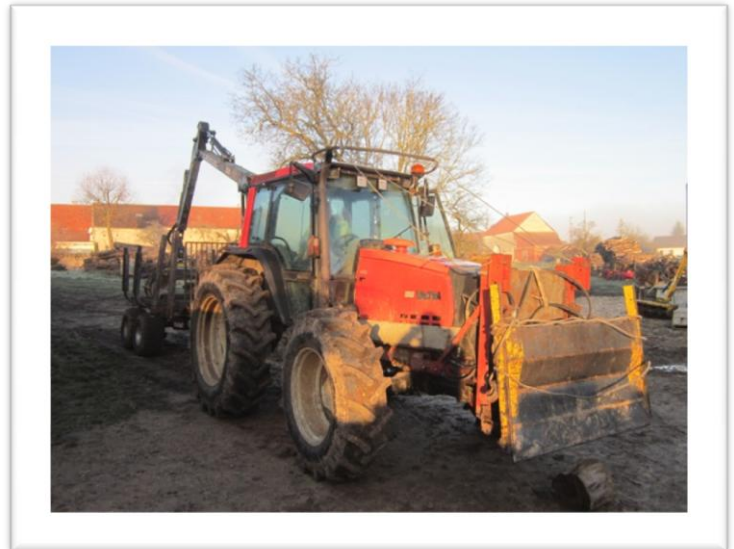
**The Valtra on Alliance AF333 agro-forestry tyres**

Mr. Terrillon favoured Alliance brand over another leading name for its good price positioning. He observes that the traction is good due to deep lugs, flat pattern with the steel belt construction and sharper shoulders. Also self-cleaning is excellent due to the ideally spaced lugs.

The tyre's improved forestry compound provides excellent resistance to cutting and chipping, which is a common problem in the logging service. He has also never faced a puncture due to the shoulder to shoulder steel belts. Also there are no damages in the usually vulnerable areas between lugs.

Since the steel belts provide a flatter and rectangular footprint the ground pressure distribution is even which enhances traction in muddy conditions. The wider treads also aid in better ground pressure distribution. He also observes that there are no cuts or damages to sidewall, an attribute to the extra strong sidewall construction of the AF333.
